Building Conservation Journal

Time for a revival

Chris McCollum and **Kenny Moore** describe the technical, philosophical and practical stages involved in the conservation of an historic stone obelisk

Needle points

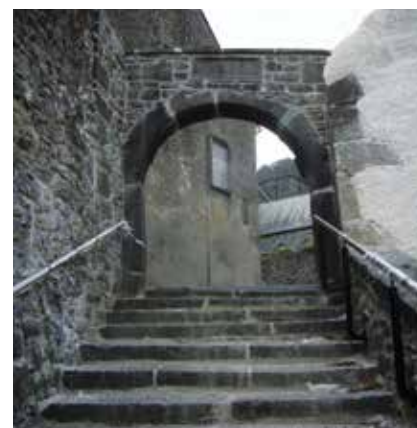
▲ 17th-century St Canice's Steps and Arch, Kilkenny, where masonry repairs and repointing of used feebly hydraulic hot-mix mortars

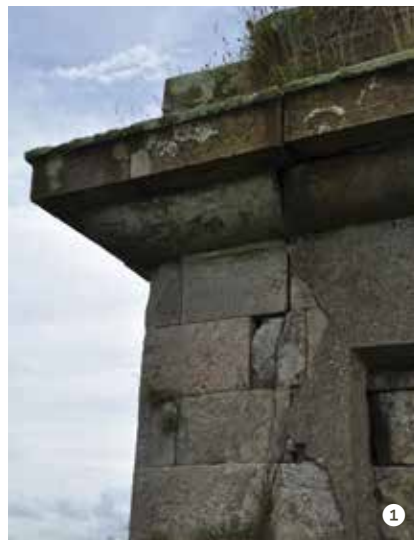
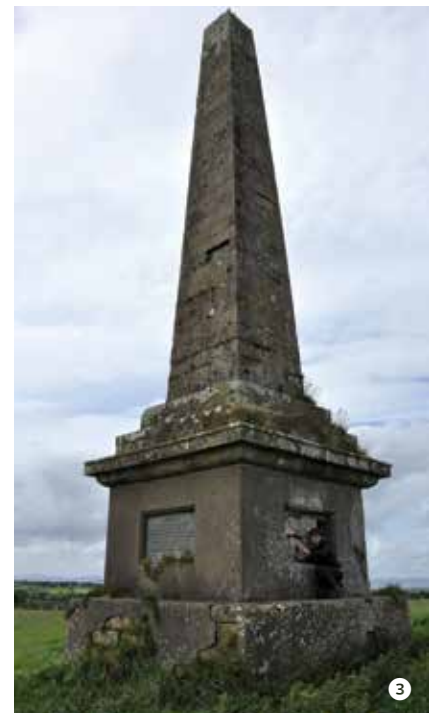
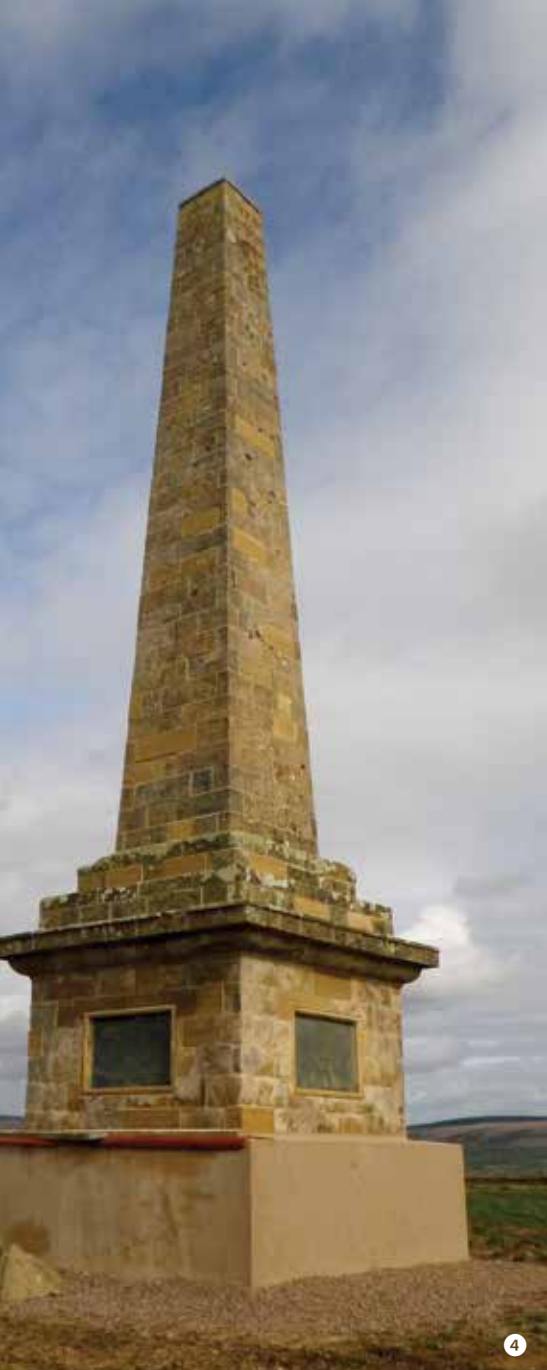
❶ Second tier of obelisk with original ashlar covered in cement render; the latter had failed, resulting in failure of masonry as well

❷ Replacement of obelisk's apex stone.

❸ The obelisk as conservation work starts and ❹ once complete with the former apex stone placed at the base of the steps

A number of stones were dislodged and the cement-based render was failing, characteristically pulling the face off the stone below. Finally, much of the original

moulded stone had mechanical damage where it had been keyed to allow the application of cement render. Enough moulding remained to allow the original profiles to be determined.

The apex stone was replaced due to its very poor condition, but has been retained at the base of the structure to allow visitors to see the original mason's mark found on its underside. The two missing slate plaques were remade using fragments of the original to create a template for the lettering style.
